## Effect of acid-etching procedure on selected physical properties of mineral trioxide aggregate

**Kayahan MB, Nekoofar MH, Kazandağ M, Canpolat C, Malkondu O, Kaptan F, Dummer PMH.** Effect of acid-etching procedure on selected physical properties of mineral trioxide aggregate. *International Endodontic Journal* 42, 1004–1014, 2009.

**Aim** To evaluate the effect of acid-etch procedures on the compressive strength and surface microhardness of tooth-coloured mineral trioxide aggregate (MTA).

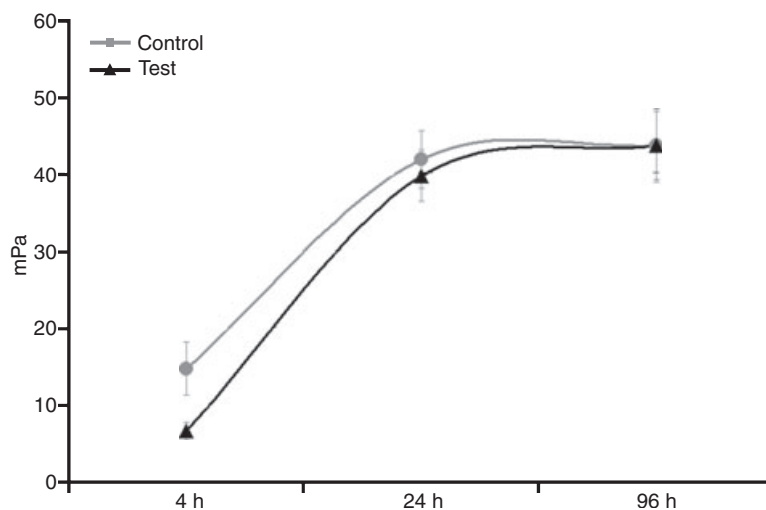
**Figure 1** Mean compressive strength (MPa) of intact and etched specimens after 4, 24 and 96 h.

The results of the compressive strength testing are shown in Fig. 1. In the experimental groups, the lowest compressive strength (mean = 6.438 MPa, SD =

2.360) was observed on the specimens etched after 4 h. There was a statistically significant difference between compressive strength values of specimens etched after 4 h compared with those groups etched after 24 and 96 h ( $P < 0.0001$ ). However, there was no statistically significant difference between specimens etched after 24 and 96 h respectively.

Statistically significant differences in compressive strength values between test and control groups occurred only after 4 h ( $P < 0.0001$ ).

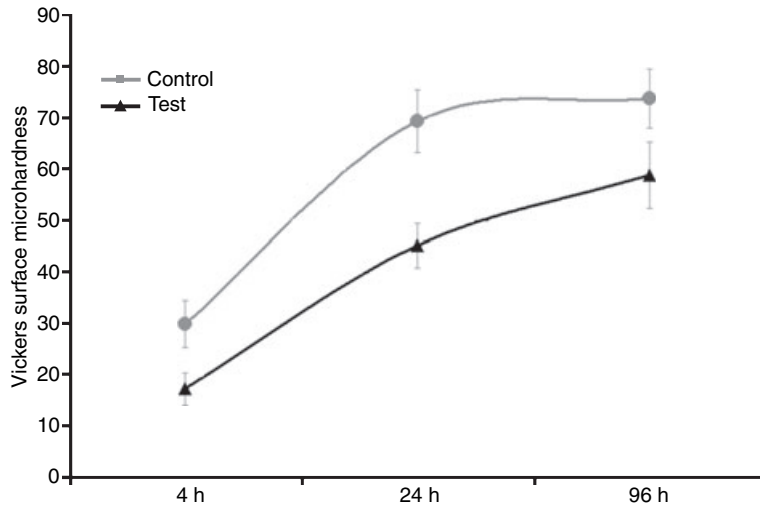
**Figure 2** Mean Vickers surface microhardness of intact and etched surfaces after 4, 24 and 96 h.

The results of the surface microhardness test are shown in Fig. 2. In the group that was exposed to the acid-etch procedure, the lowest Vickers surface microhardness value (mean = 17.269, SD = 6.382) was observed after 4 h. There was a statistically significant difference between specimens etched after 4, 24 and 96 h respectively ( $P < 0.0001$ ).

There was a statistically significant difference in Vickers surface microhardness values between test and control groups after 4, 24 and 96 h respectively ( $P < 0.0001$ ). The surface microhardness values of the test group were lower than the control group at all time intervals (Fig. 2).

In the control group, there was a statistically significant difference in Vickers surface microhardness values between specimens after 4 h compared with the other control groups ( $P < 0.0001$ ). However, there was no statistically significant difference between control specimens after 24 and 96 h respectively.

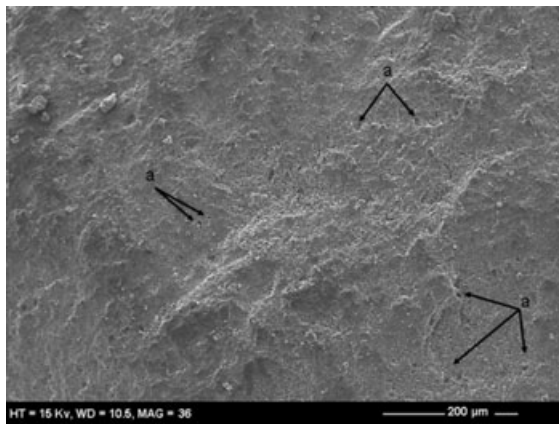
**Figure 3** Intact surface of unetched mineral trioxide aggregate after 24 h. An amorphous poorly crystallized superficial gel structure and the cross-section of some microchannels (a) can be seen (original magnification: 36 $\times$ ).

The SEM examination revealed distinct morphological differences between the intact (Figs 3–7) and the etched MTA surfaces (Figs 8–13). No morphologically dissimilarity was observed within the test and control groups at 24 and 96 h after mixing (Figs 3, 4, 9 and 10). The surface microstructure of the unetched MTA (control groups) after both time period were similar and showed an amorphous poorly crystallized superficial gel structure at 36 $\times$  magnification (Figs 3 and 4). The presence of needle-like crystals was a common finding in control groups at 500 $\times$  and 700 $\times$  magnification after 24 and 96 h (Figs 5 and 6). At 1187 $\times$  magnifi-

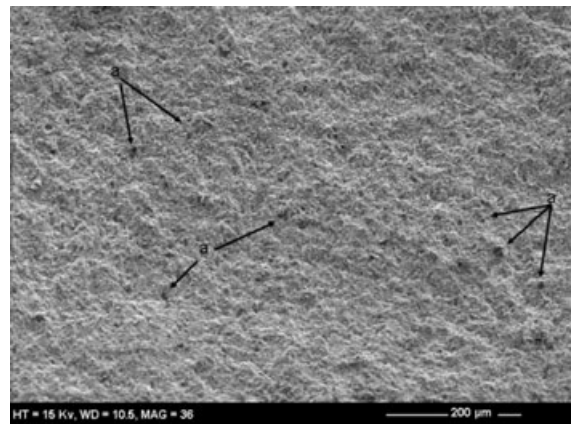
**Figure 4** Intact surface of unetched mineral trioxide aggregate after 96 h. An amorphous poorly crystallized superficial gel structure and the cross-section of several microchannels (a) can be seen (original magnification: 36 $\times$ ).

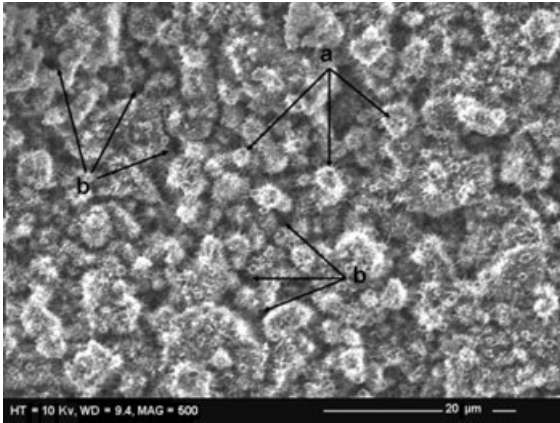
**Figure 5** Intact surface of unetched mineral trioxide aggregate after 24 h. Irregular needle-like crystals that cover globular formations (a) and cross-sections of several microchannels (b) can be seen (original magnification: 500×).

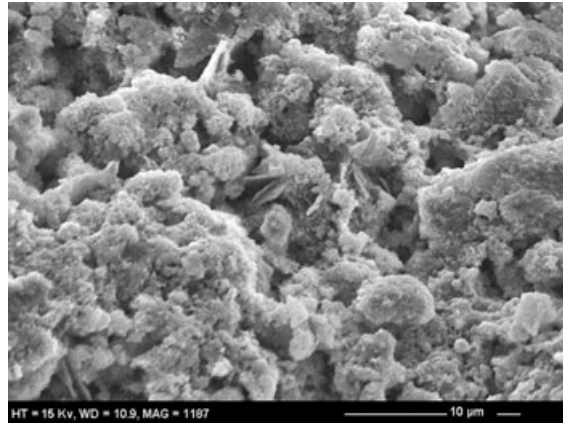
**Figure 7** Intact surface of unetched mineral trioxide aggregate after 96 h. The relatively uncrystallized superficial gel structure containing the globular particles can be seen (original magnification: 1187×).

cation, a plain poorly crystallized superficial gel structure containing globular aggregate particles was observed in the control group (Fig. 7). After etching procedures at 24 or 96 h, a selective loss of matrix from around the crystalline structures were observed at 36 $\times$ , 500 $\times$  and 700 $\times$  magnifications that produced a relatively uniform 'honeycomb' etched pattern without penetrating deeply or removing substantial amounts of the cement (Figs 8–10). No needle-like crystals were observed over the etched surfaces. Loss of the needle-like crystals was a significant morphological difference between etched and intact (control) surfaces (Figs 5, 6, 9 and 10). In addition, acid-etch procedures after 24 and 96 h revealed notable crystalline structures such

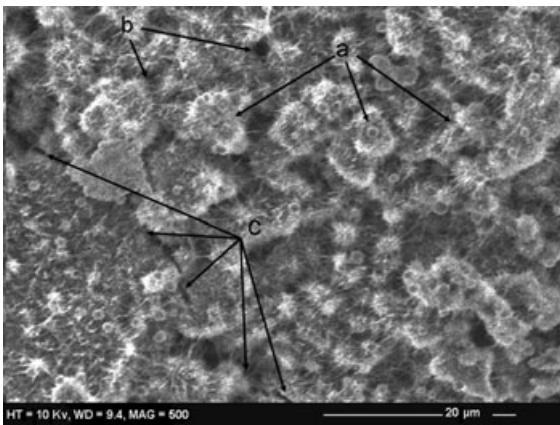
**Figure 6** Intact surface of unetched mineral trioxide aggregate after 96 h. Irregular needle-like crystals that cover globular formations (a), cross-sections of some microchannels (b) and a microchannel running transversely (c) can be seen (original magnification: 500×).

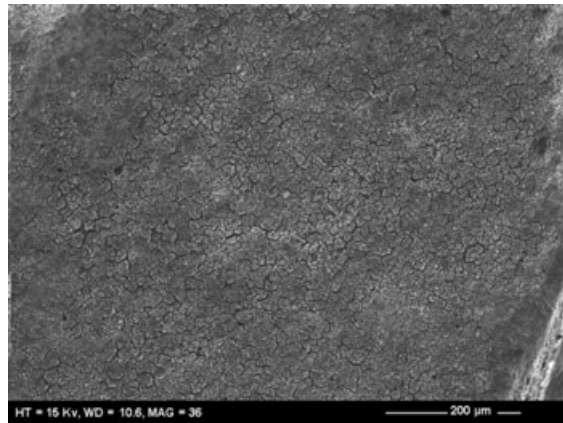
**Figure 8** Etched surface of mineral trioxide aggregate after 24 h. A relatively uniform 'honeycomb' etched pattern can be seen (original magnification: 36×).

as plate-shaped and laminated crystals on the MTA surface (Figs 11–13). There was no evidence of superficial gel structure throughout the surface of the etched groups after 24 and 96 h at the various magnifications (Figs 8–13).

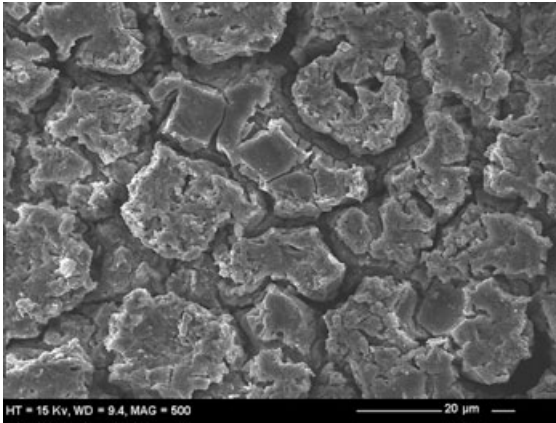
**Figure 9** Etched surface of mineral trioxide aggregate after 24 h. Selective loss of matrix from around the crystalline structures and relatively uniform 'honeycomb' etched pattern with minimal loss of the cement can be seen. No needle-like crystals were observed (original magnification: 500×).

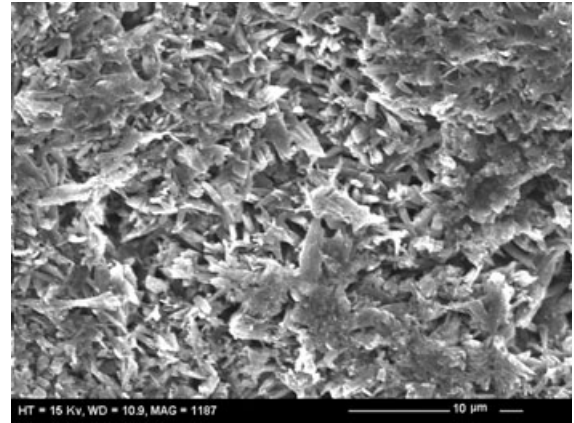
**Figure 11** Etched surface of mineral trioxide aggregate (MTA) after 96 h. Selective elimination of matrix with minimal loss of the cement can be seen. Laminated and plate-shaped crystals are notable and visible on the MTA surface. No needle-like crystals were observed (original magnification: 1187×).

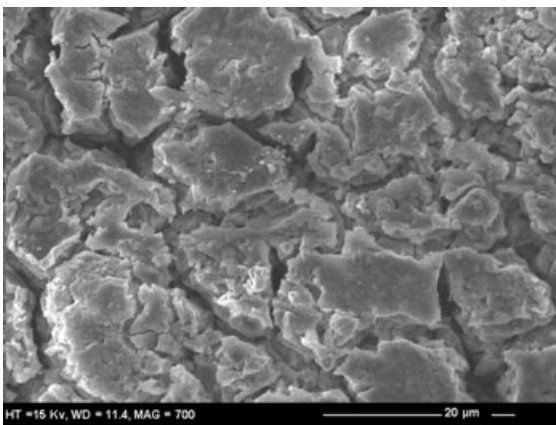
**Figure 10** Etched surface of mineral trioxide aggregate after 96 h. Selective loss of matrix from around the crystalline structures and relatively uniform 'honeycomb' etched pattern with minimal loss of the cement can be seen. No needle-like crystals were observed (original magnification: 700×).

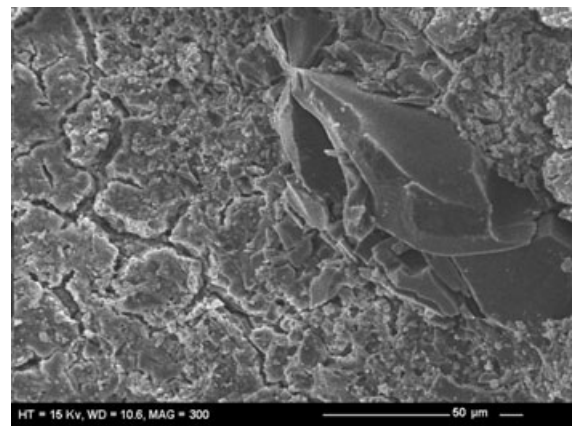
**Figure 12** Etched surface of mineral trioxide aggregate (MTA) after 96 h. Selective elimination of matrix with minimal loss of the cement can be seen. Laminated and plate-shaped crystals were a notable feature on the MTA surface. No needle-like crystals were observed (original magnification: 300×).

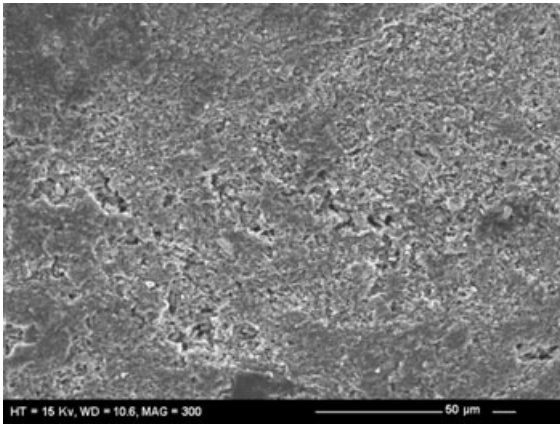
**Figure 13** Etched surface of mineral trioxide aggregate (MTA) after 24 h. Selective elimination of matrix with minimal loss of the cement can be seen. Laminated and plate-shaped crystals were a notable feature on the MTA surface. No needle-like crystals were observed (original magnification: 300 $\times$ ).
